# Memorandum

SUBJECT: Upgrading of Ponce Landfill for Hazardous Waste Disposal

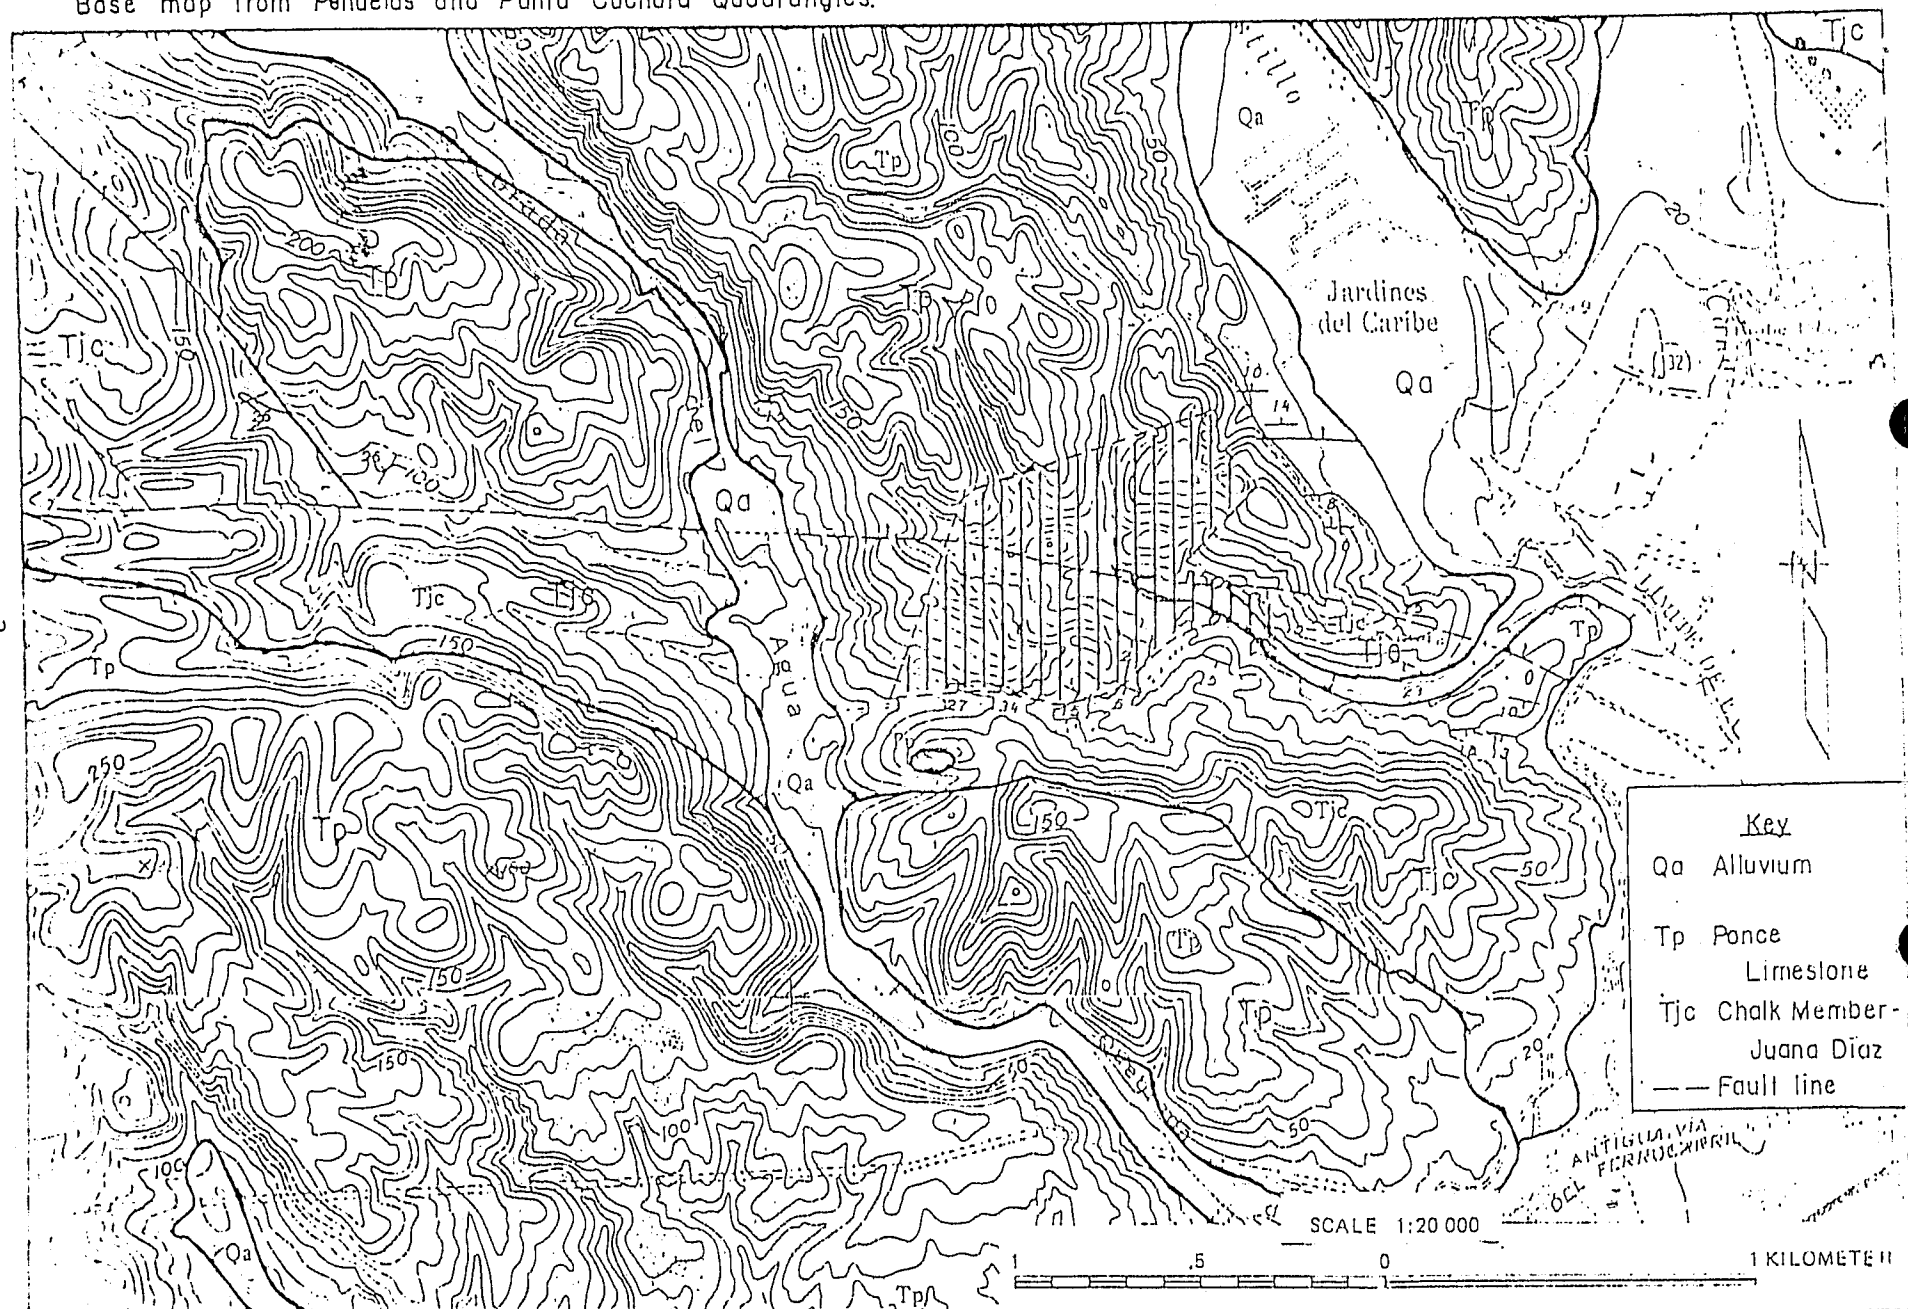
FIGURE 1  
SOILS MAP FOR PONCE MUNICIPAL LANDFILL AND SURROUNDING AREA

Soil percolation characteristics and geological description of the area may indicate possible contamination of underground waters from landfill leachate. Although, no data is available, the assessment of possible damages is recommended since the city of Ponce makes extensive use of wells. Search and investigation of wells around the facility is of paramount importance. Migration of waste contaminants may be expected through the alluvial formation. Movement due east and then due south is most probable. (See map no. 1). The alluvium in this area has been identified useful as an aquifer which typically yields on the order of 20 gpm on screened wells (McClymonds, 1972).

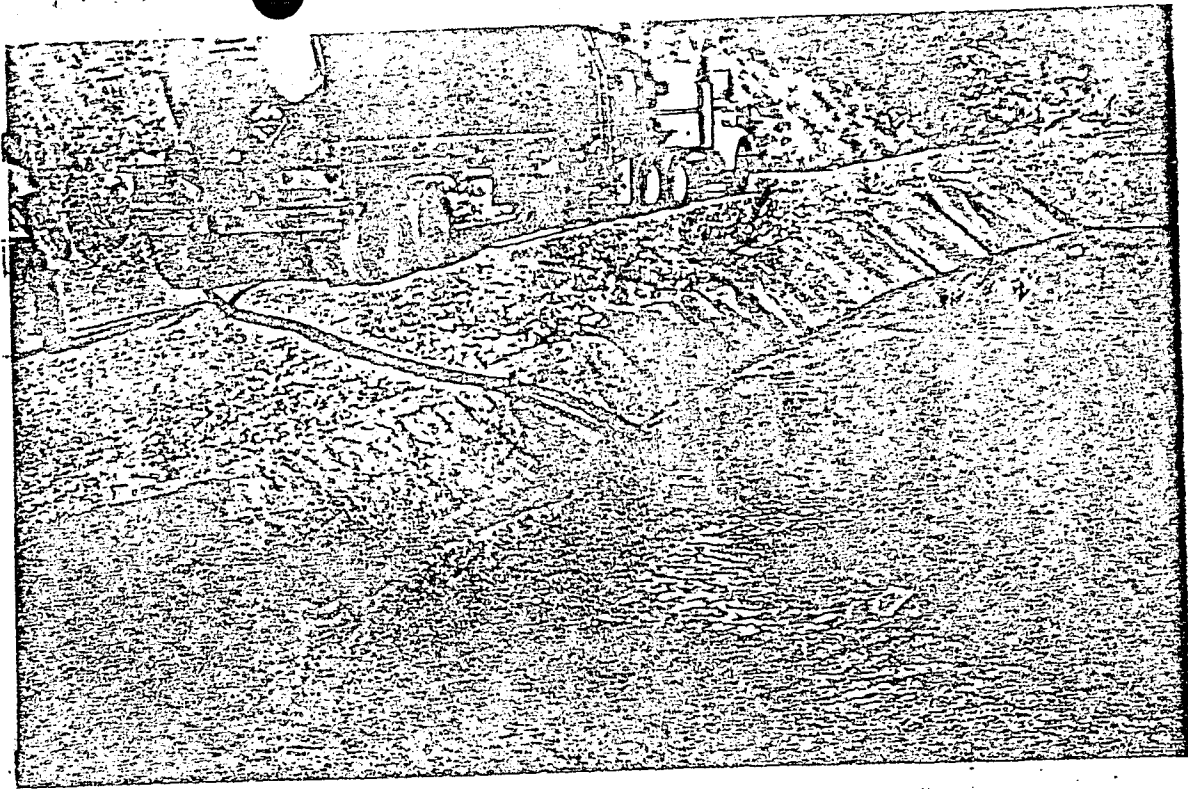
②

Photo No. 2

& 3: Panoramic view inside the property, expose  
soil and active site
